# *Blight Study*

Prepared for: **Village of Brewster**  
**50 Main Street**  
**Brewster, NY 10590**

**September 2014**

**Revised: February 2015**

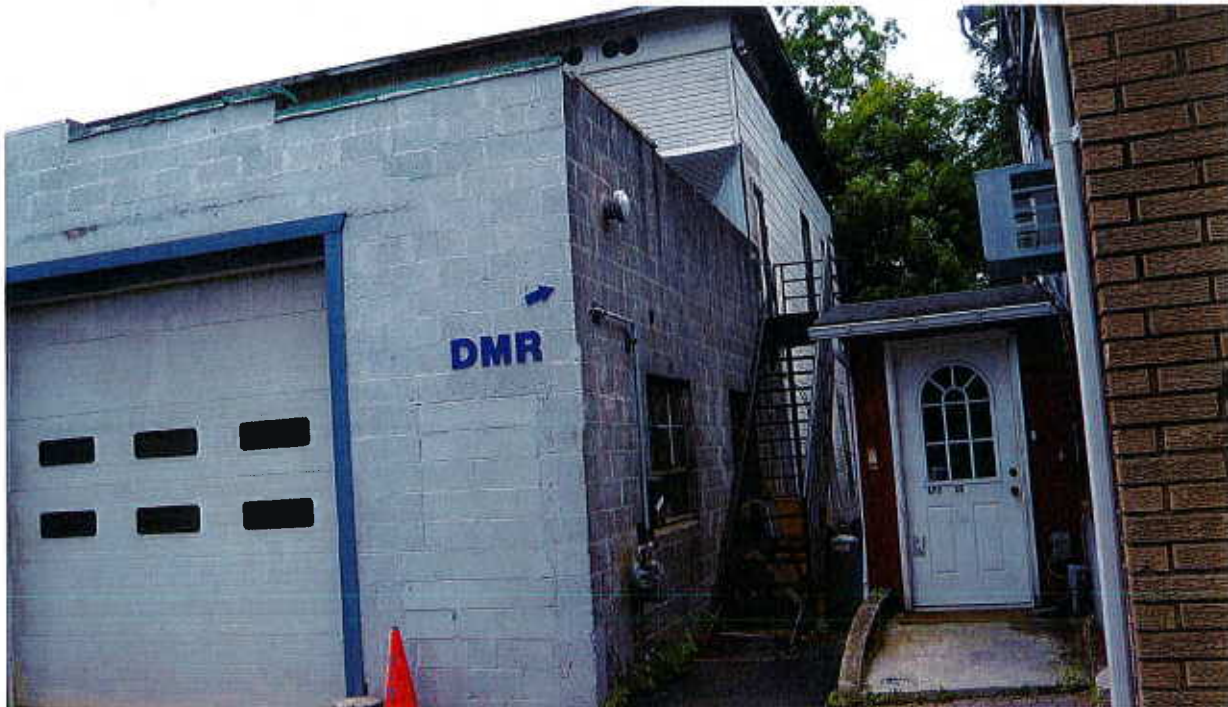
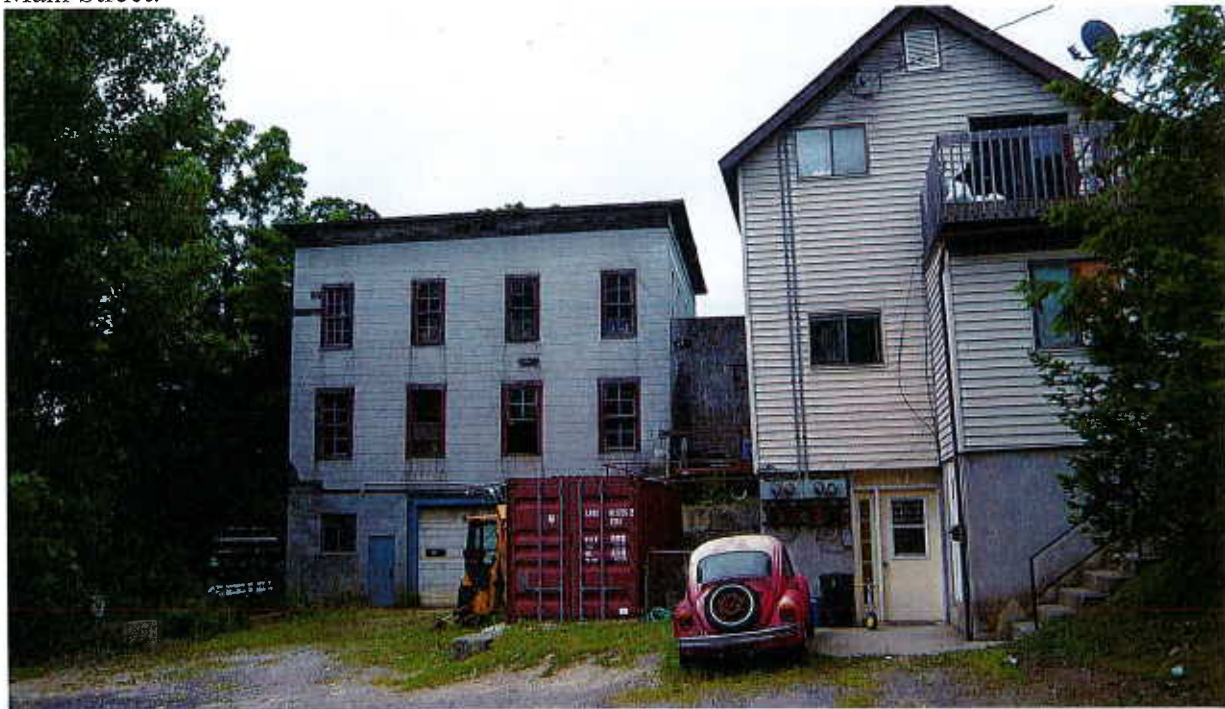
Incompatible land uses have established undesirable living conditions for abutting residents along Main Street.

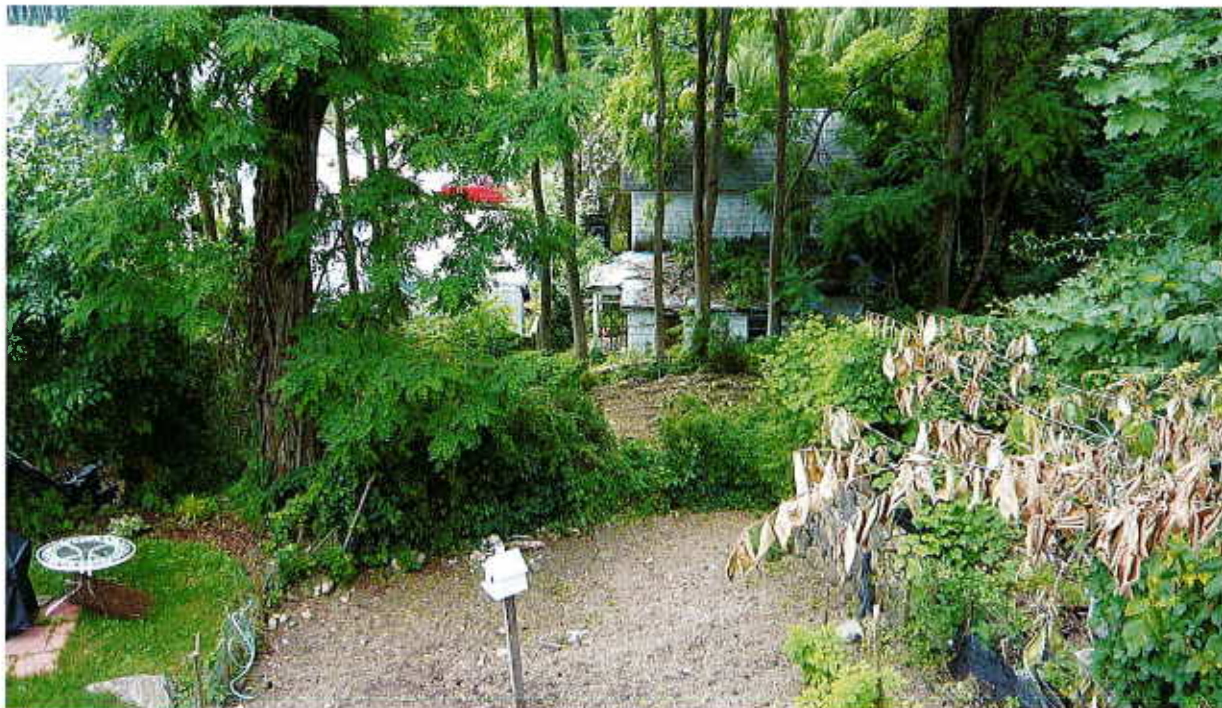
There is some vacant land along Main Street, however, the lack of development on this land is most likely due to its topography.

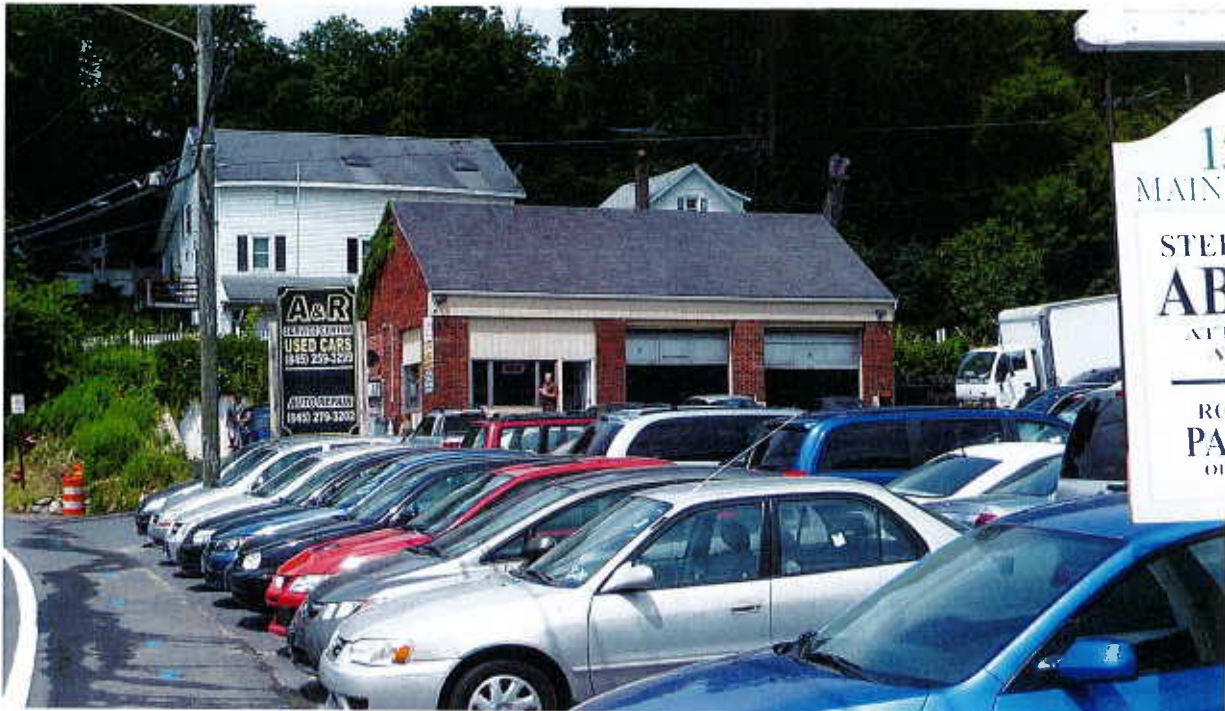
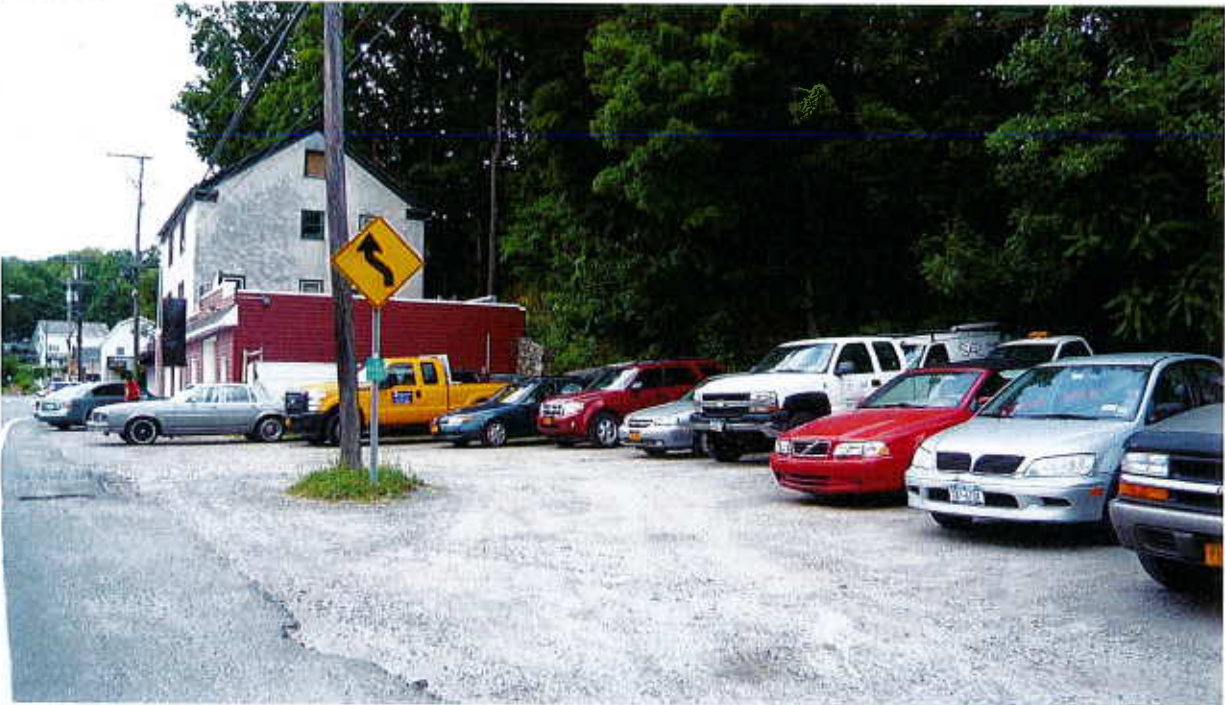
Land use incompatibility is evident on Main Street due to present auto-related uses and nearby residents.

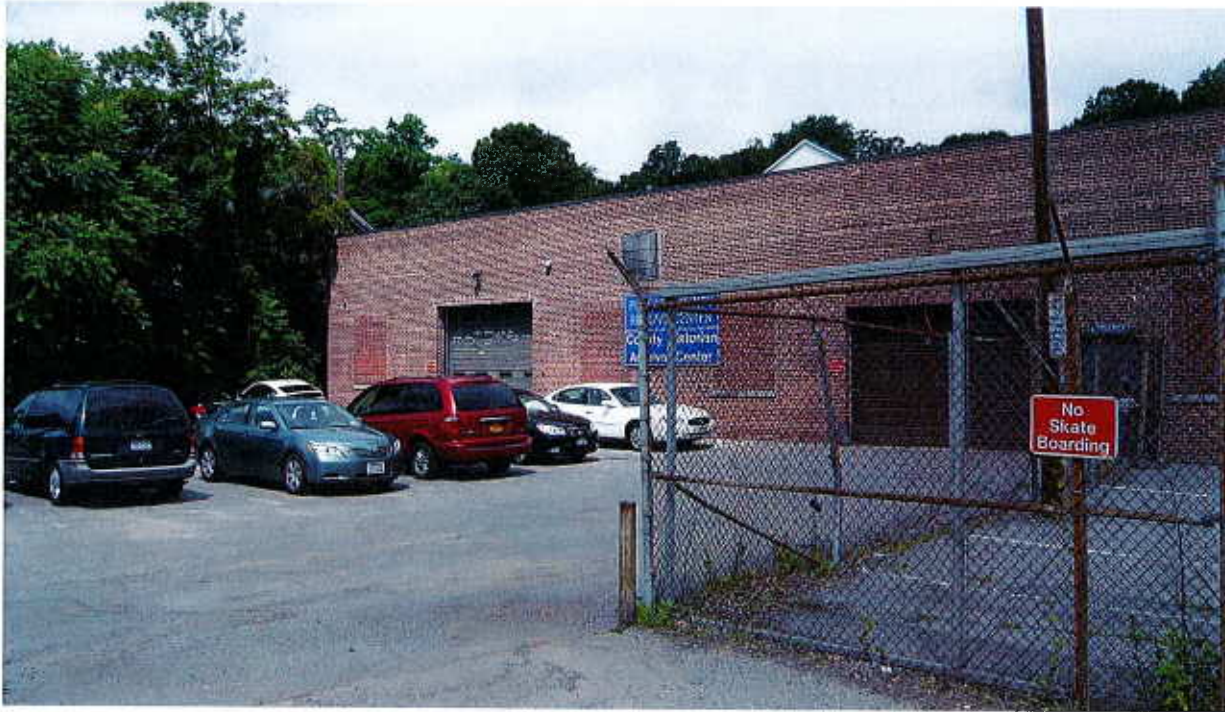
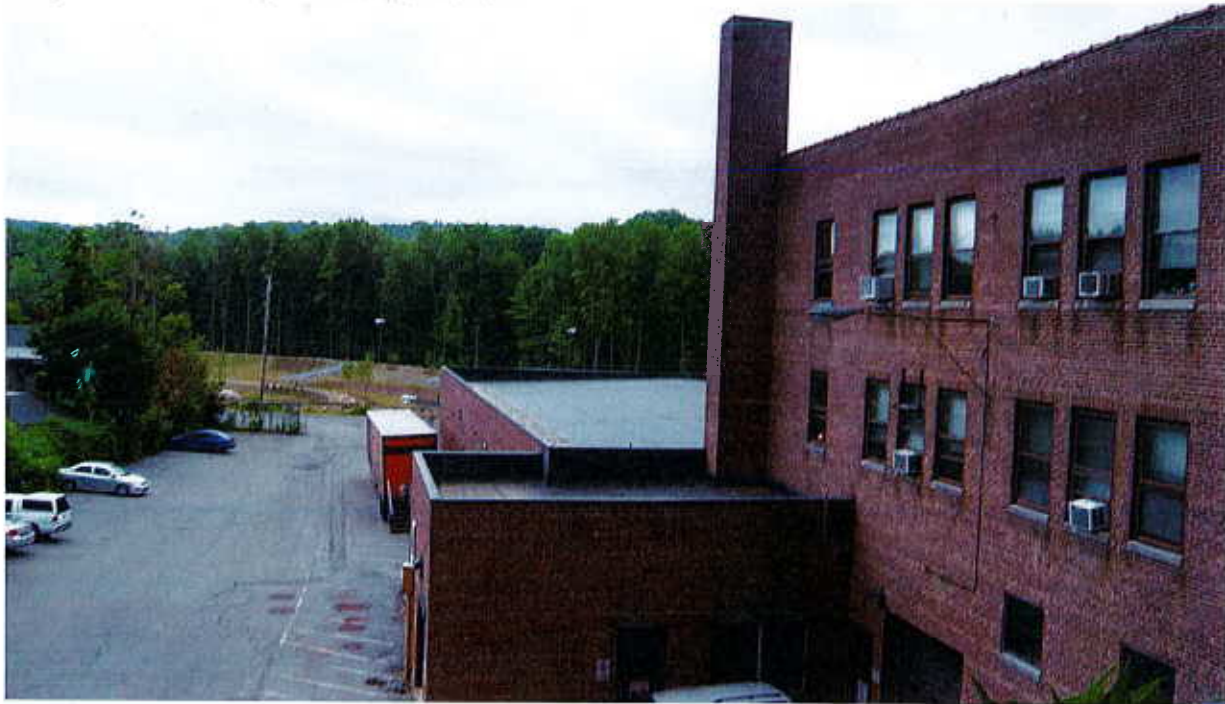
Obsolete buildings have also been identified as inefficient land uses in the downtown, including the large Putnam County Archives Building

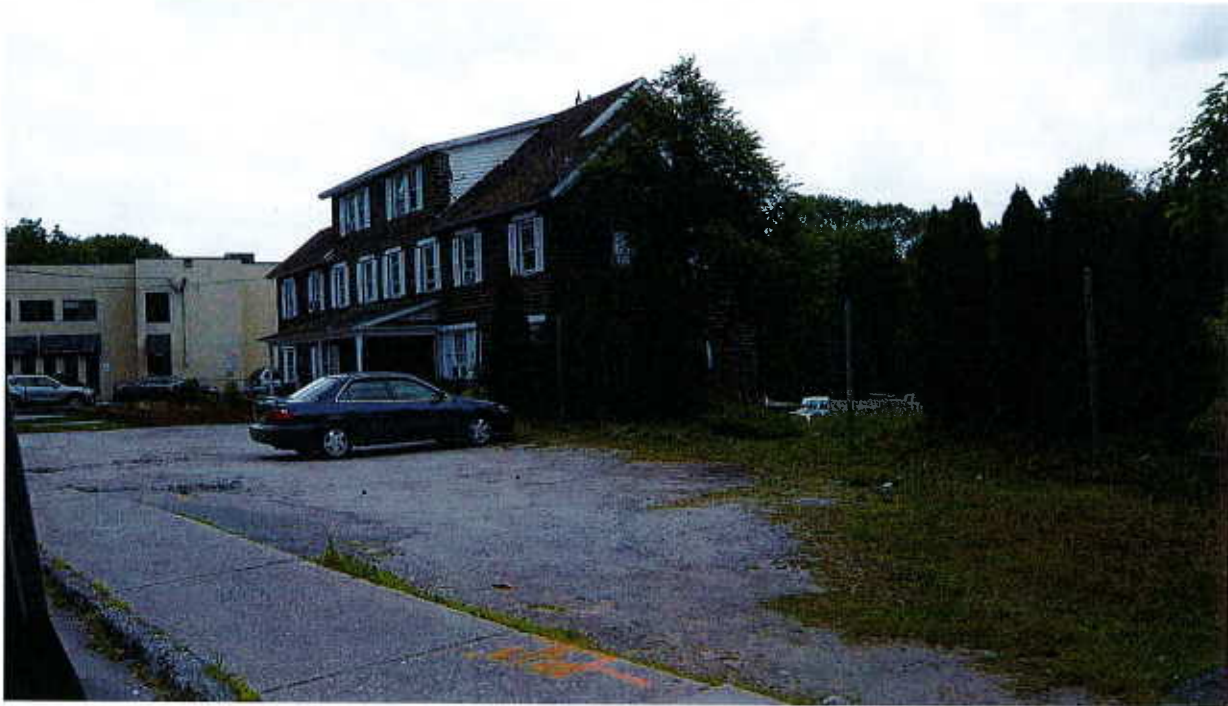
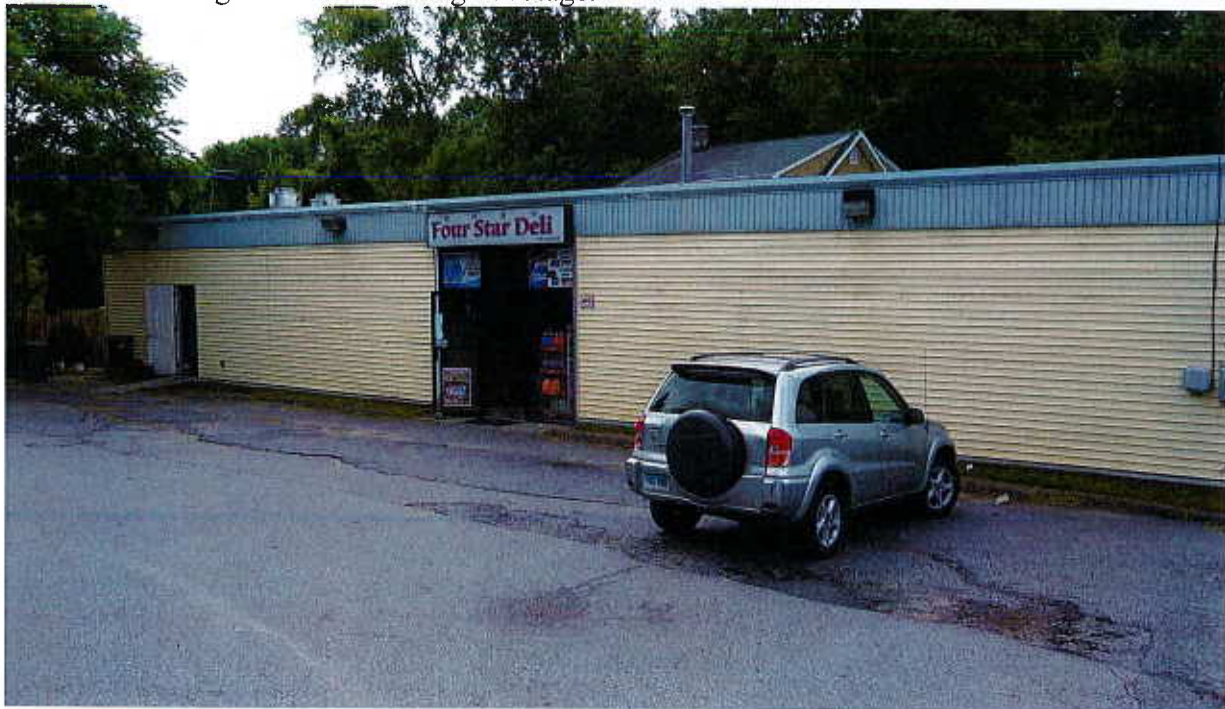
Parcels on Main Street towards the intersection of Route 6 and 22 are underutilized, containing lots with wide frontage and low building coverage.

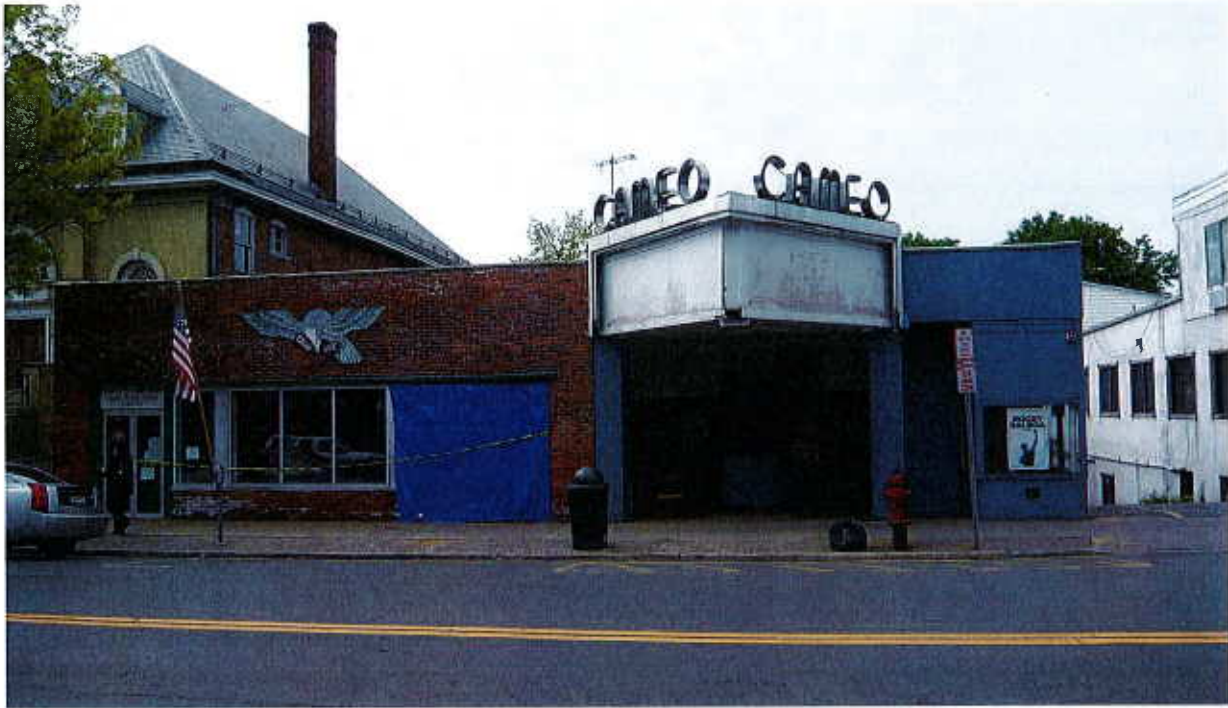
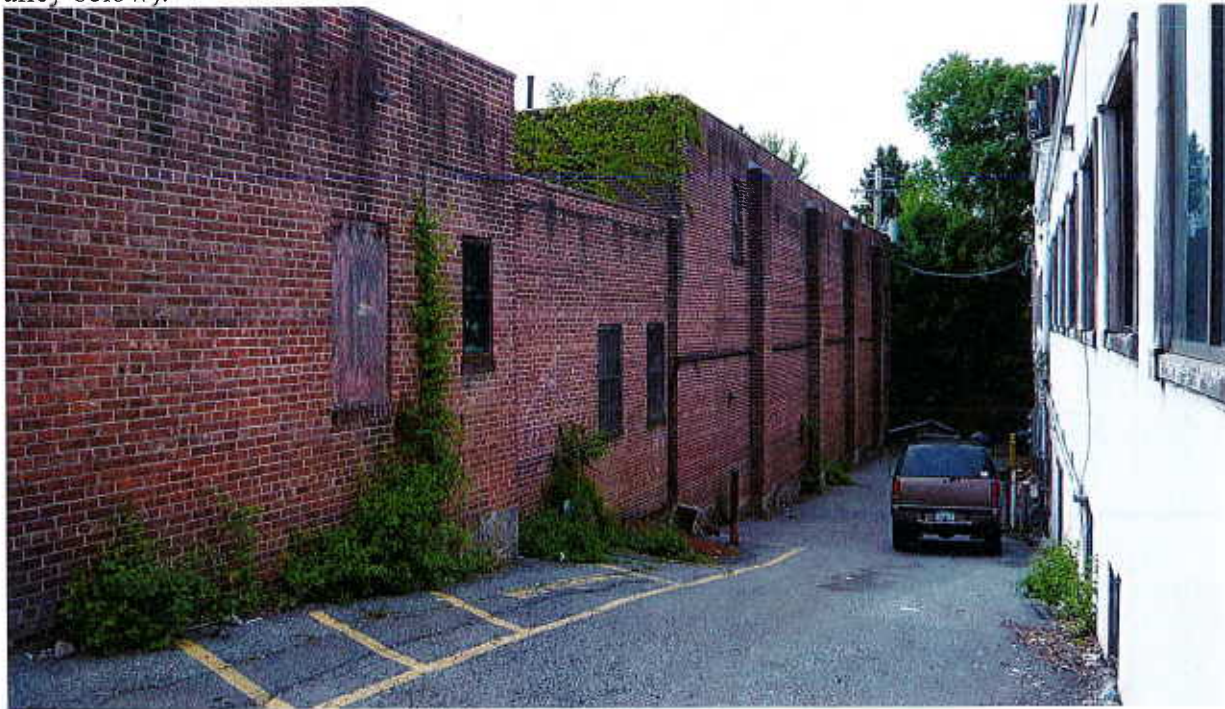
The former Cameo Theatre is an obsolete building based on the fact that it has been vacant for an extended period of time and that these types of theaters have proven to have limited potential for re-occupancy in most locations. Further, the building has extensive structural damage.

Obsolete buildings on Main Street, include the defunct Cameo Theater (front above, and its side alley below).

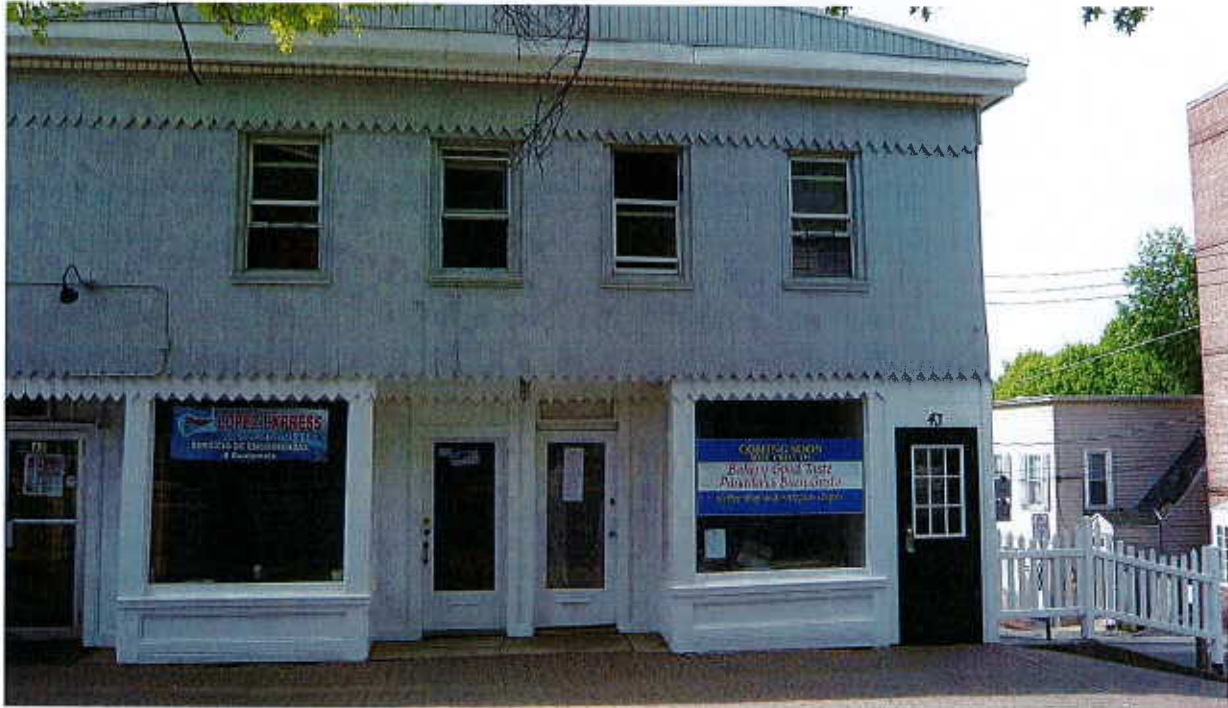
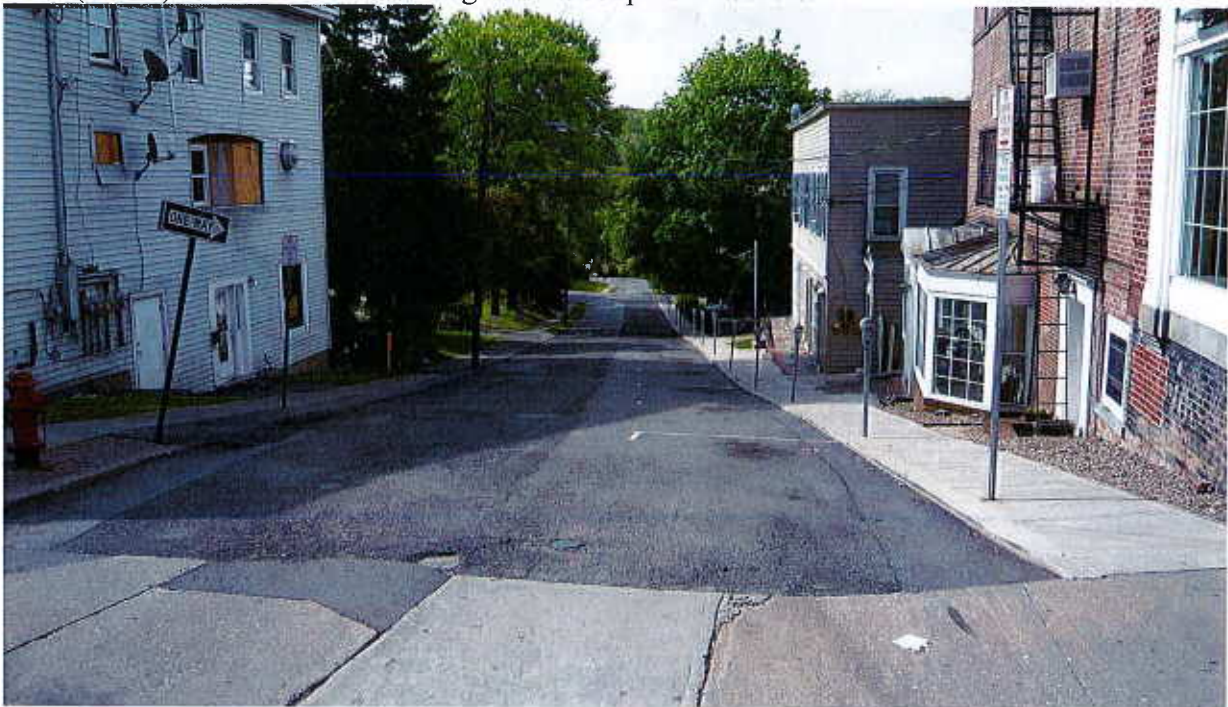
Some buildings on Main Street have enhanced the appearance on their front façades (above) but the sides (below) and rear of the buildings remain in poor condition.

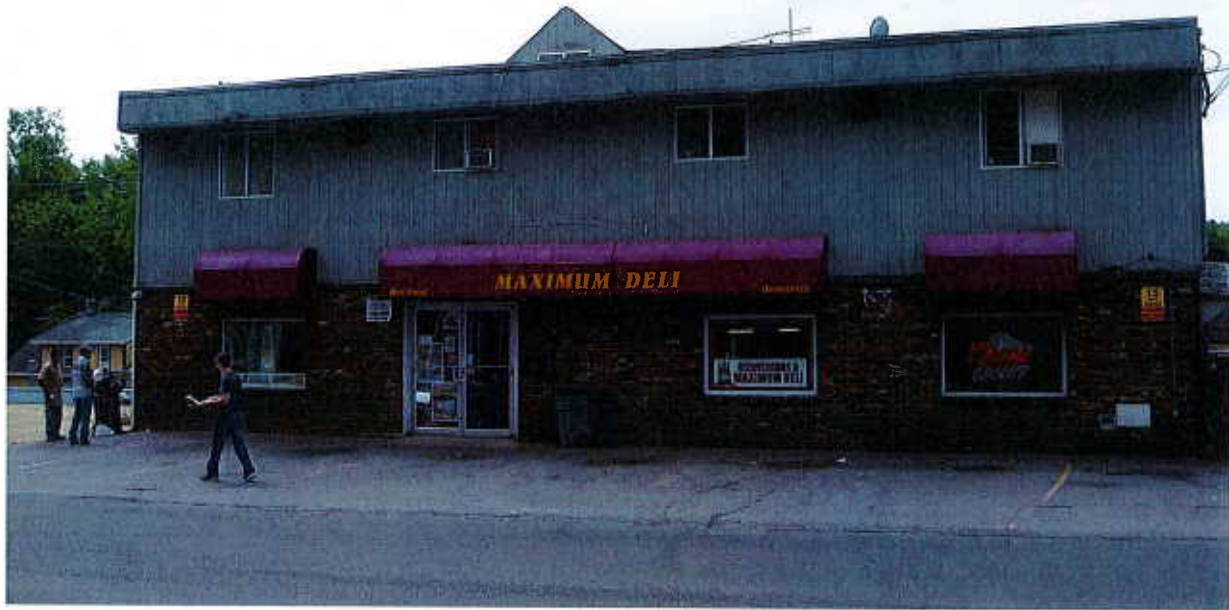
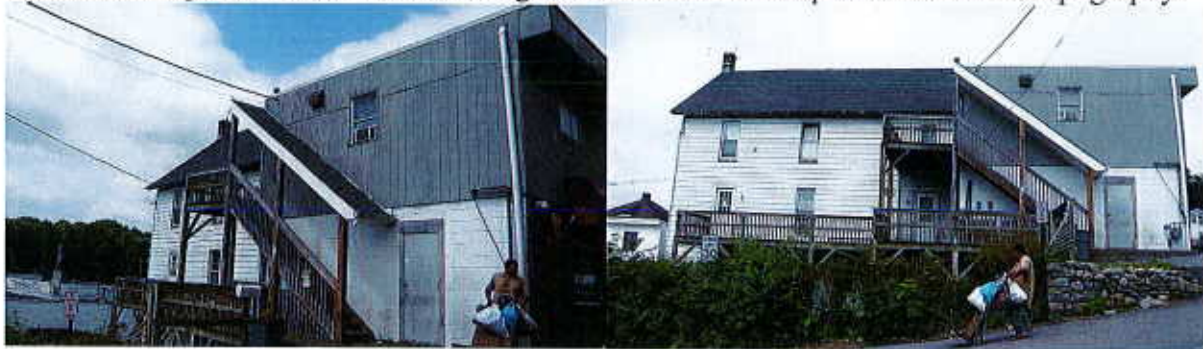
Another example of substandard building conditions and the impact of the area's topography.

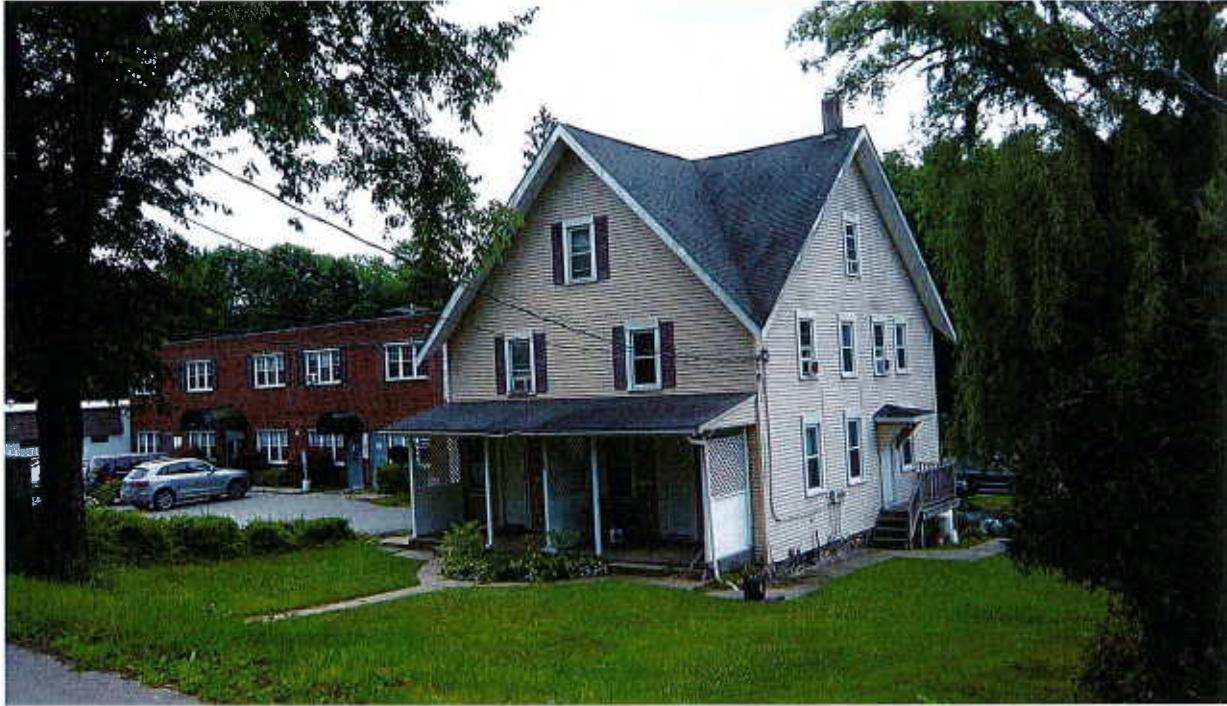
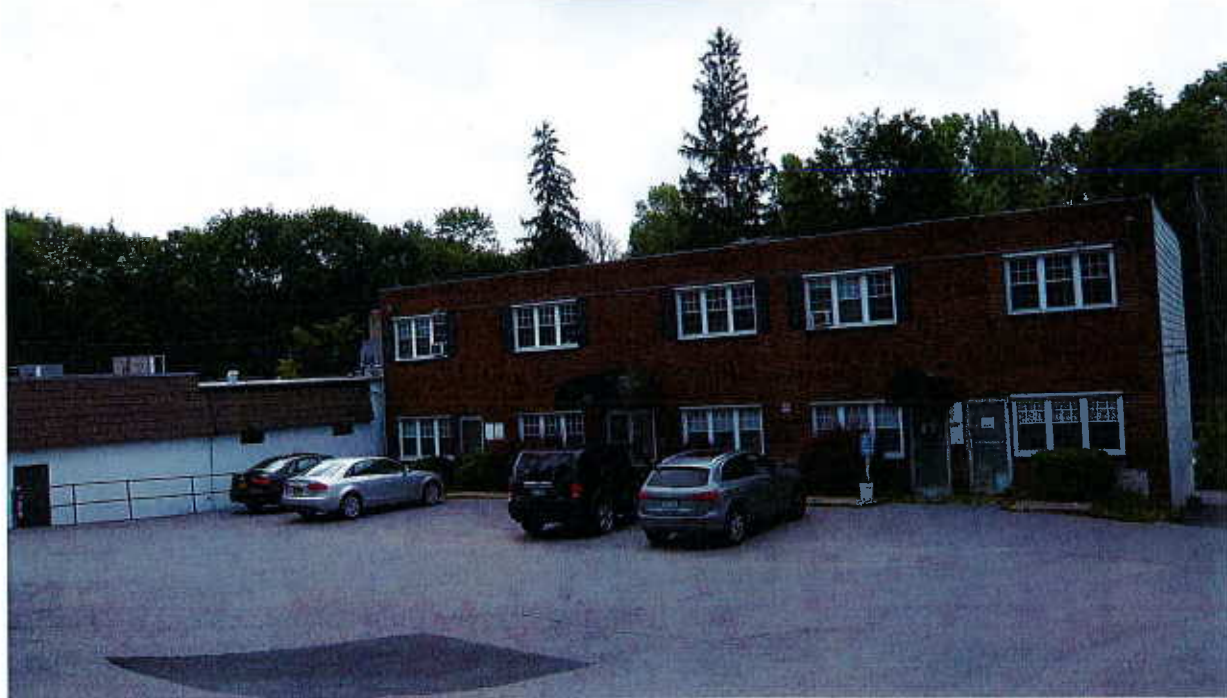
Underutilized parcels towards the eastern end of Main Street. These parcels contain large setbacks from the lot line, which creates undesirable site conditions.

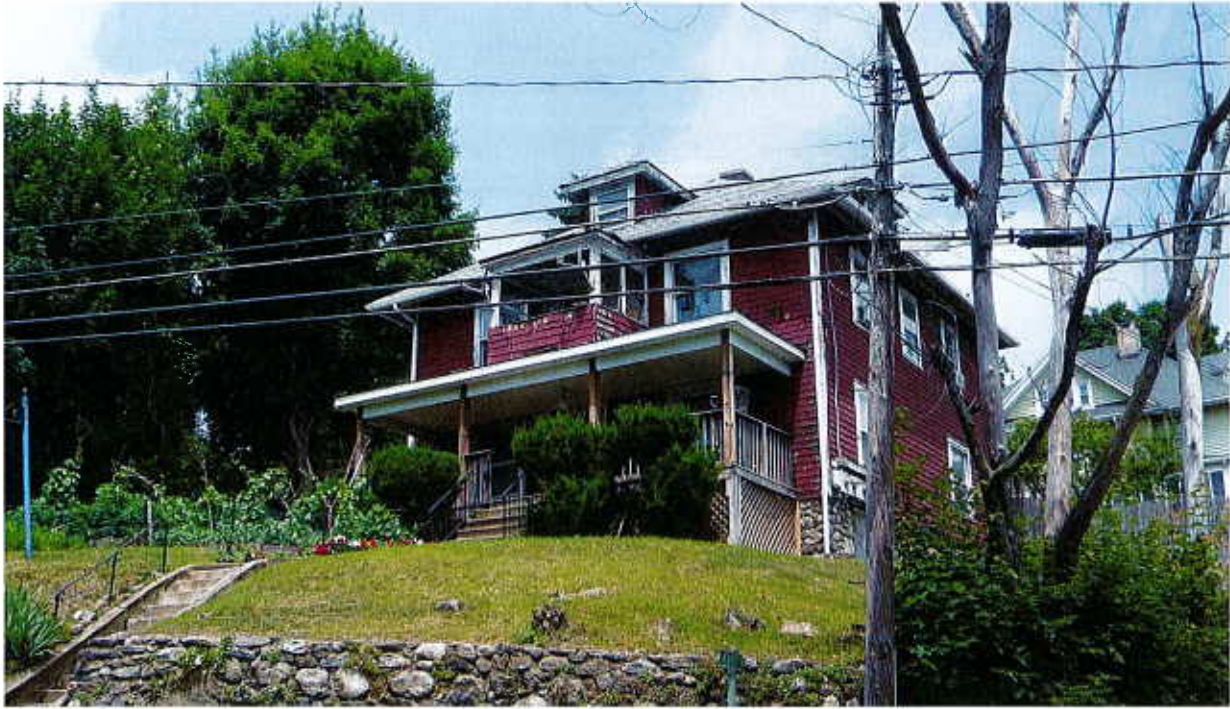
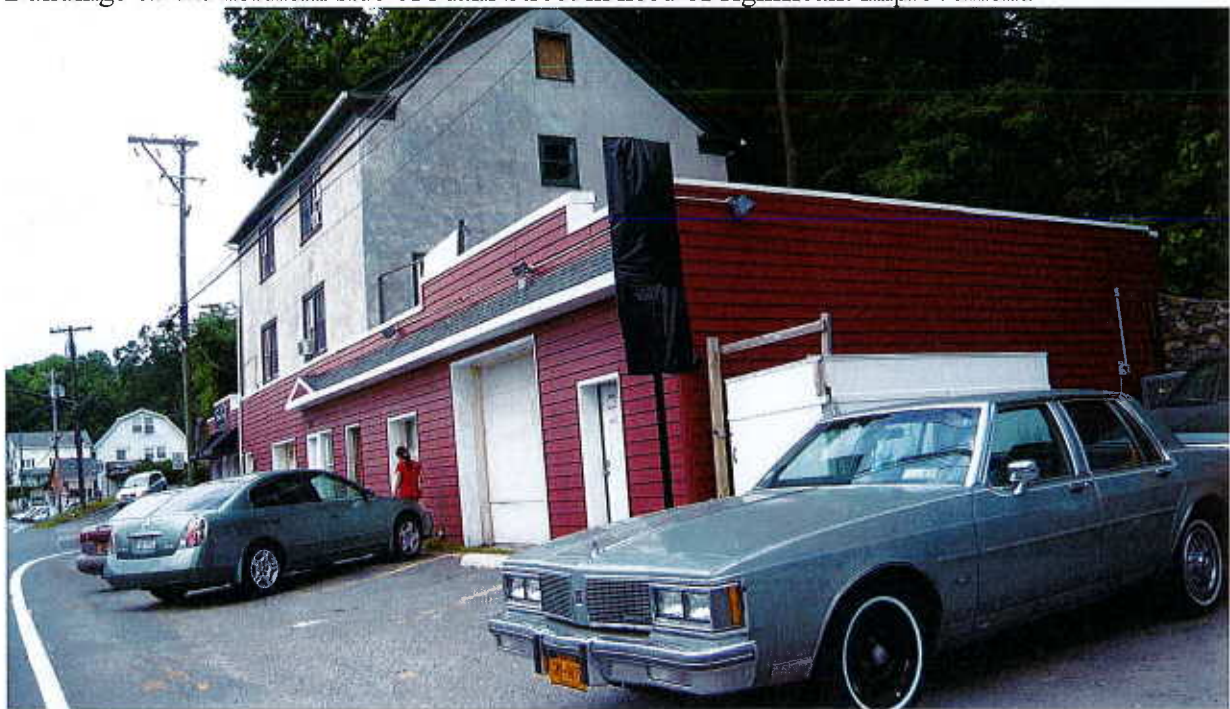
Buildings on the northern side of Main Street in need of significant improvement.

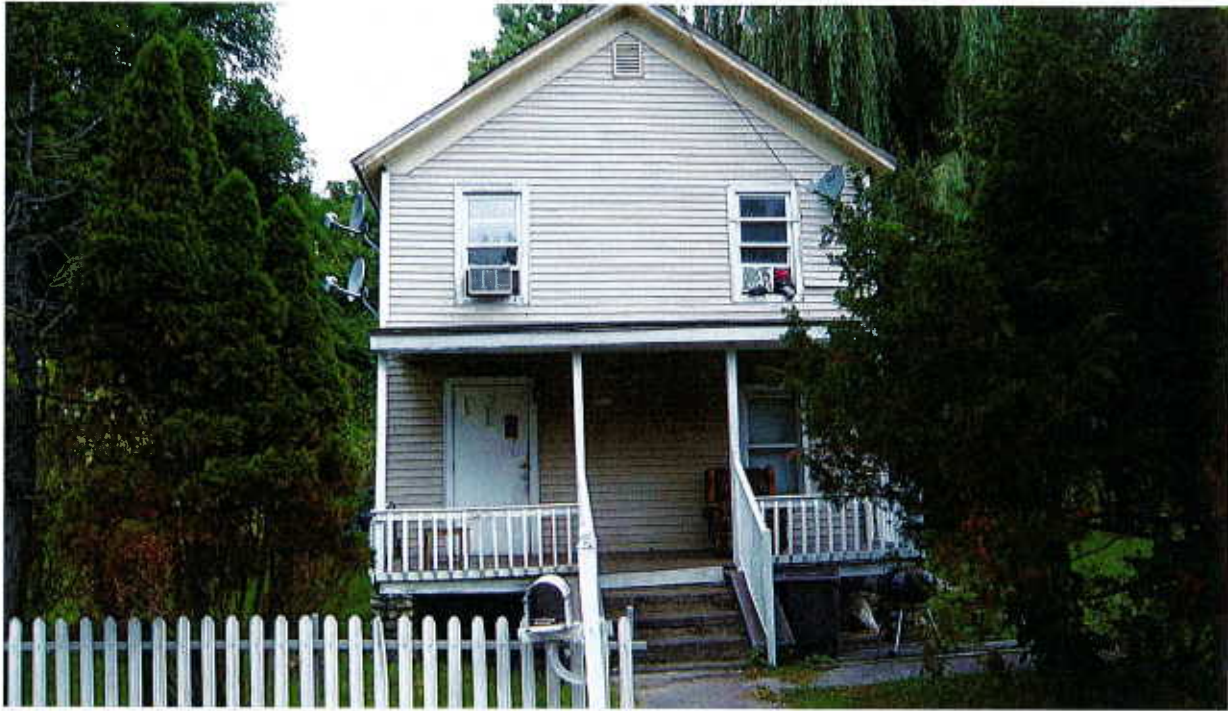
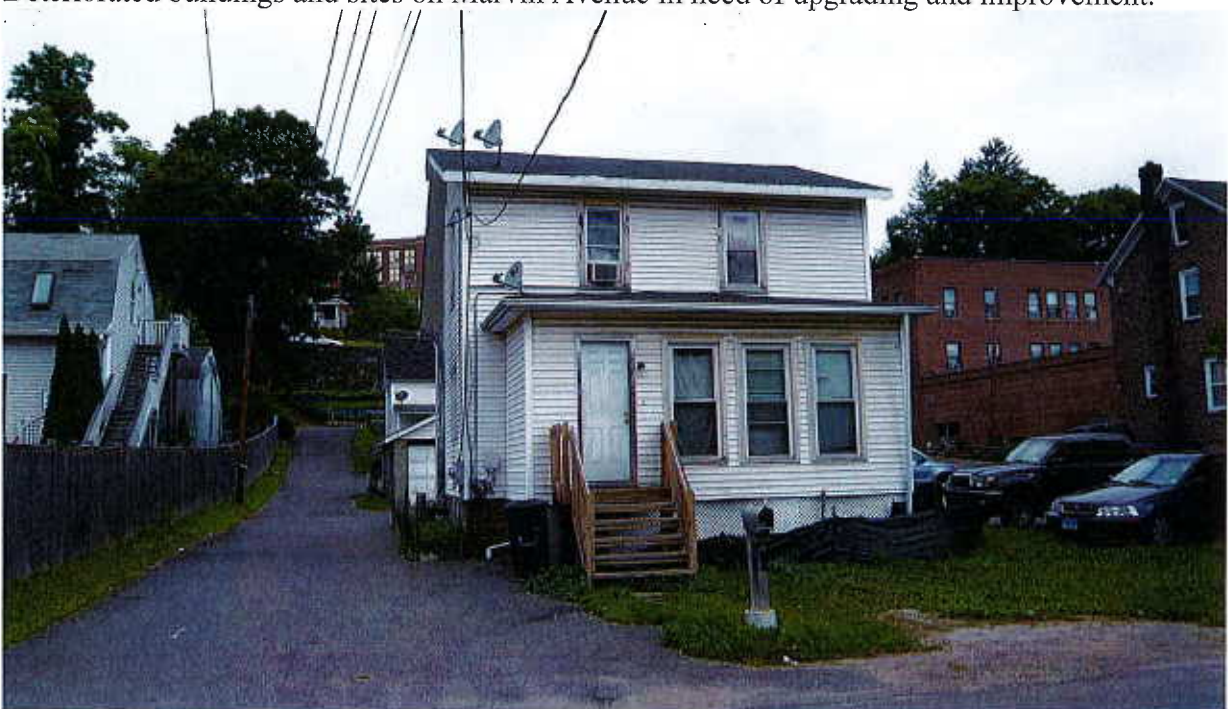
Deteriorated buildings and sites on Marvin Avenue in need of upgrading and improvement.

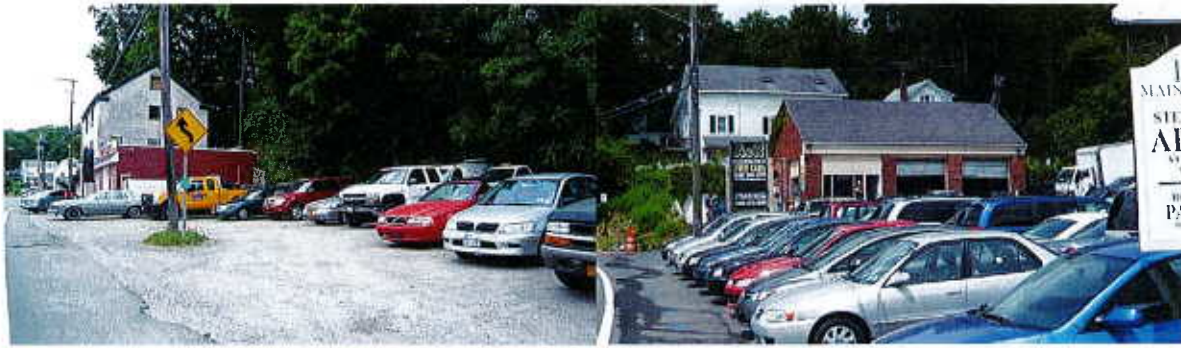
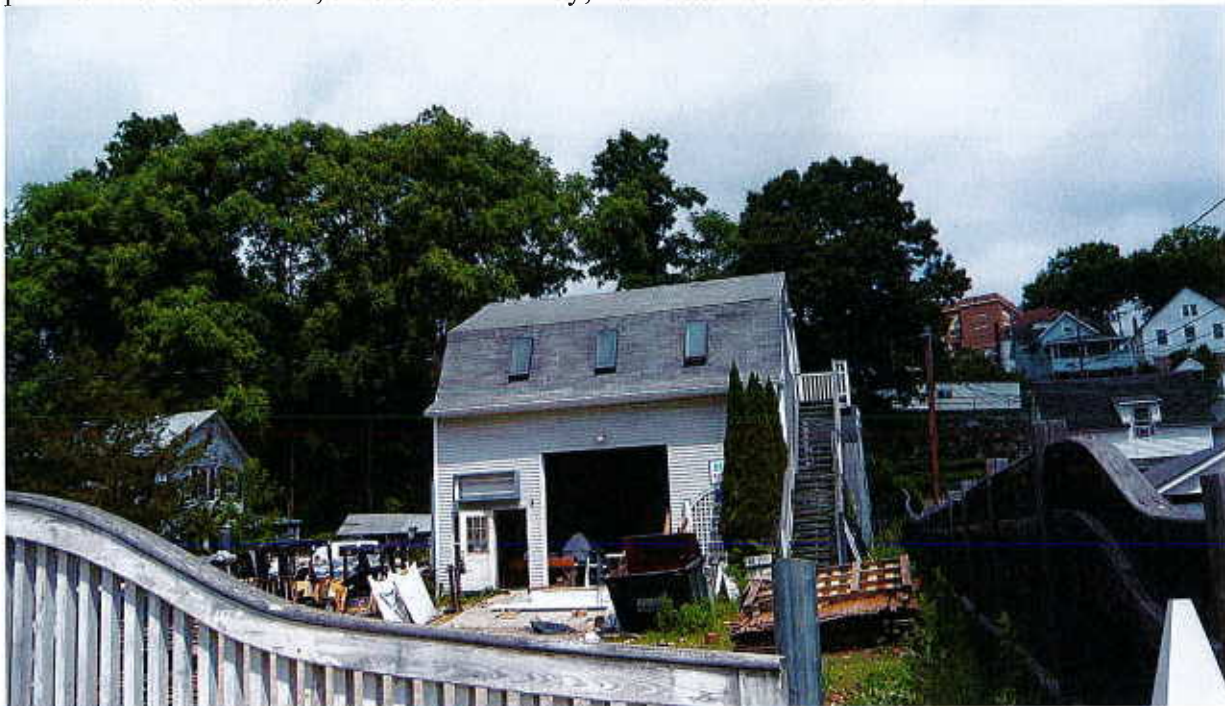
Land use incompatibility and inconsistency is evident on Main Street and Marvin Avenue due to present auto-related uses, commercial activity, and traffic circulation.

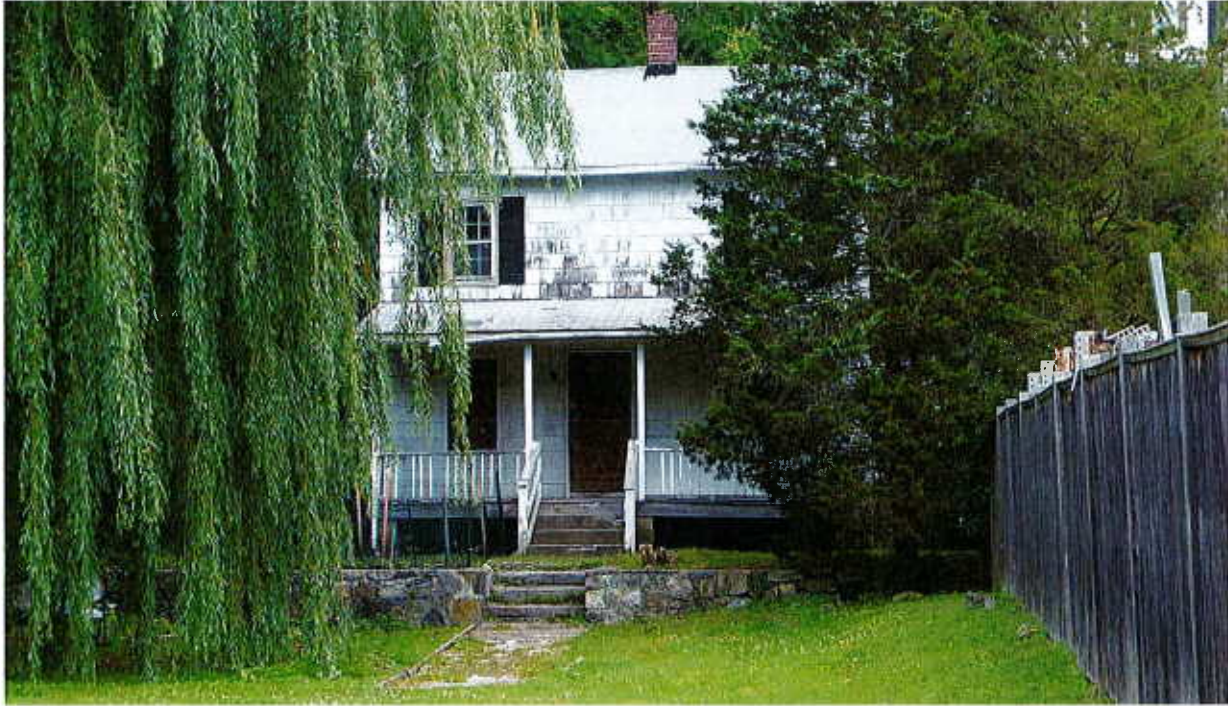
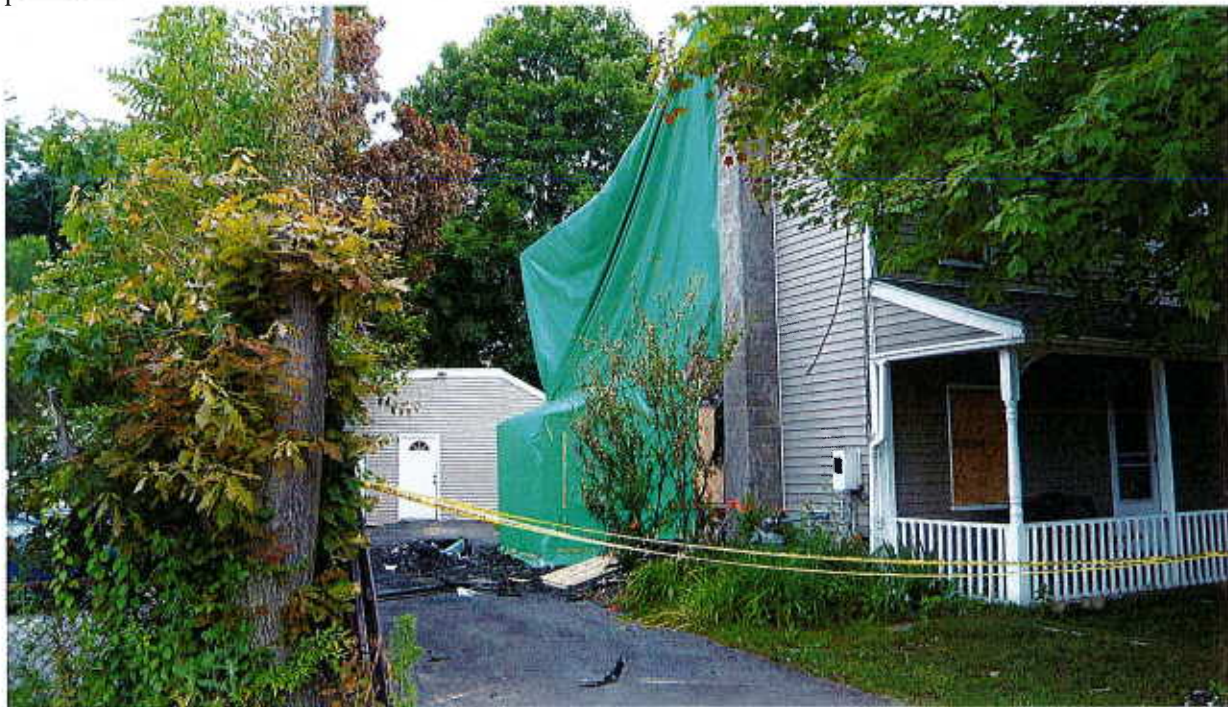
Abandoned (above) and damaged (below) housing on Marvin Avenue presents visual and functional problems

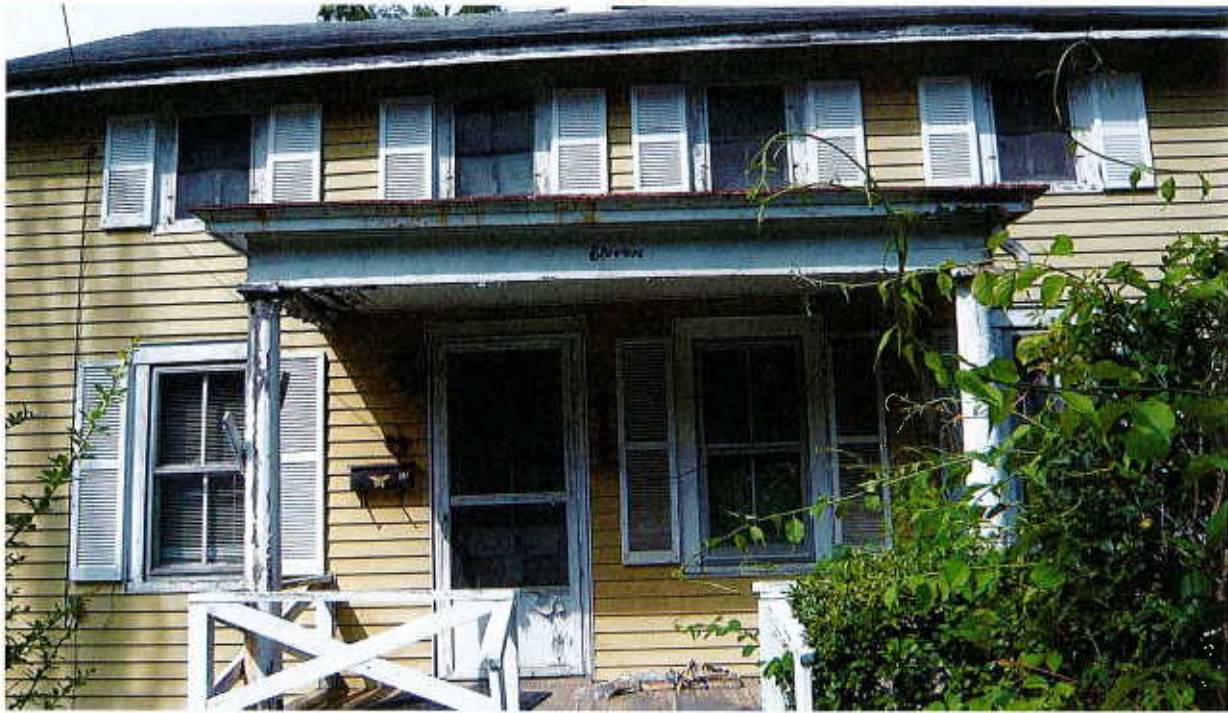
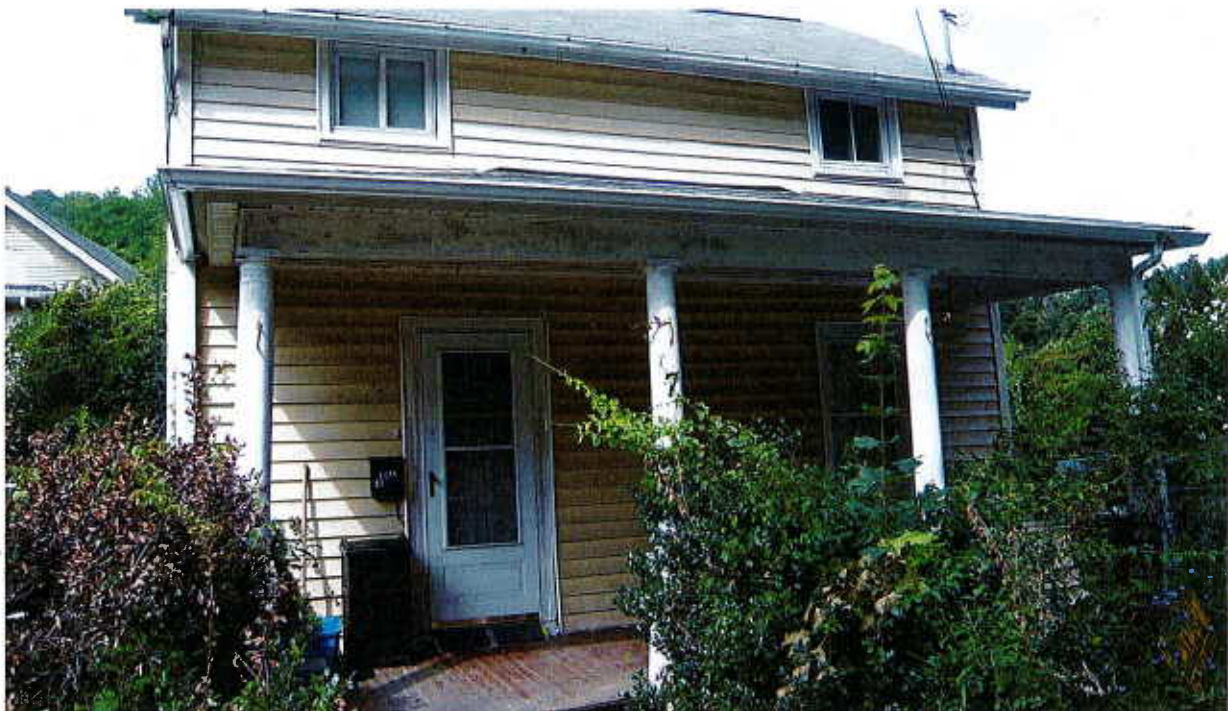
Housing on Oak Street in need of maintenance
